# Portage Creek Sediment Remediation Project Kalamazoo, Michigan

Pre-Sediment Removal Structure Feature Assessment  
Removal Areas SA3-A, SA3-B and SA3-Access

F&V Project Number: 809930

August, 2012

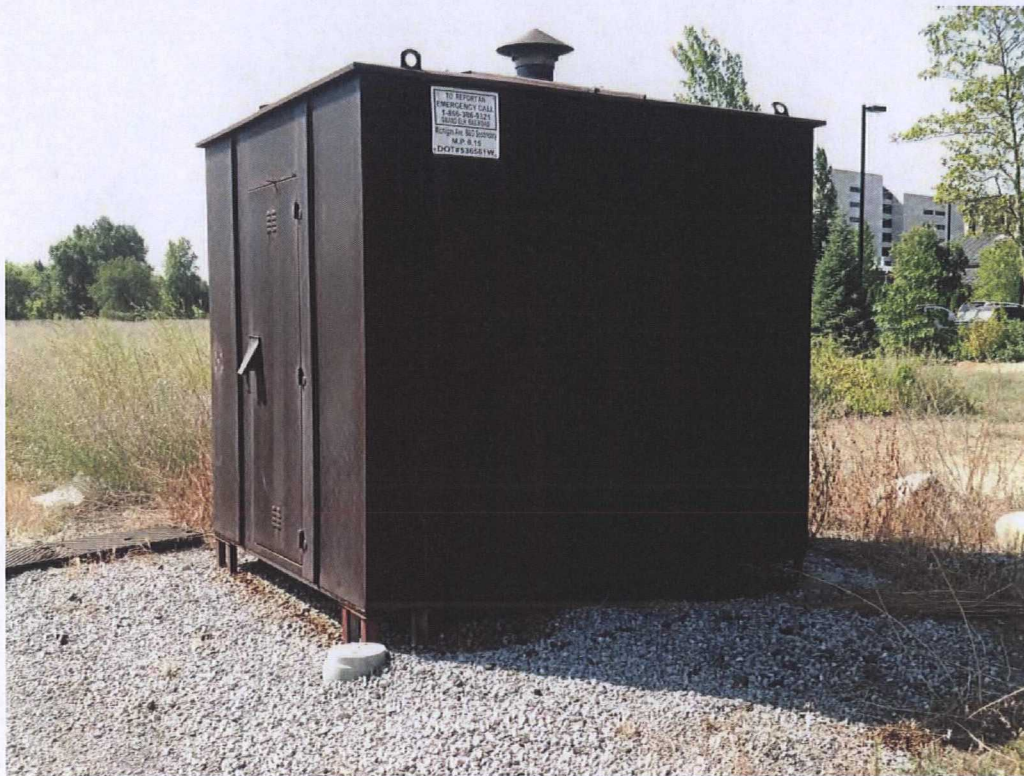
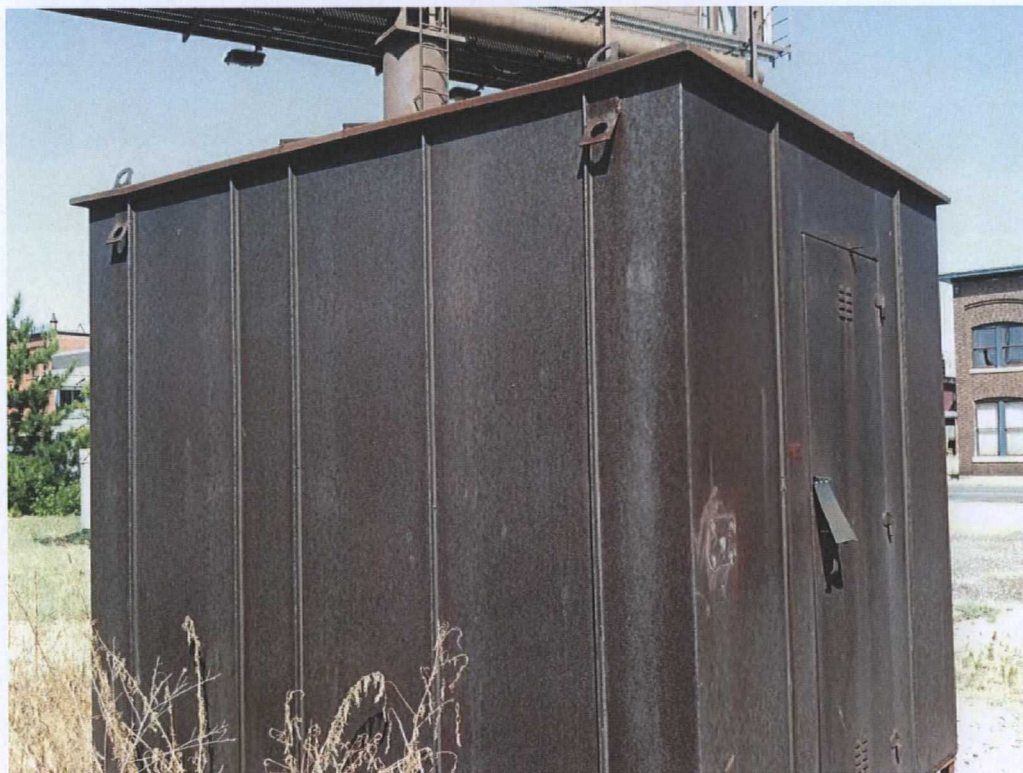
- The siding has moderate to severe surface corrosion.
- There is a sink hole under the northwest corner.
- There is an electric service panel on the west wall.

- The shed structure should be identified/protected with construction fencing or similar during the work.

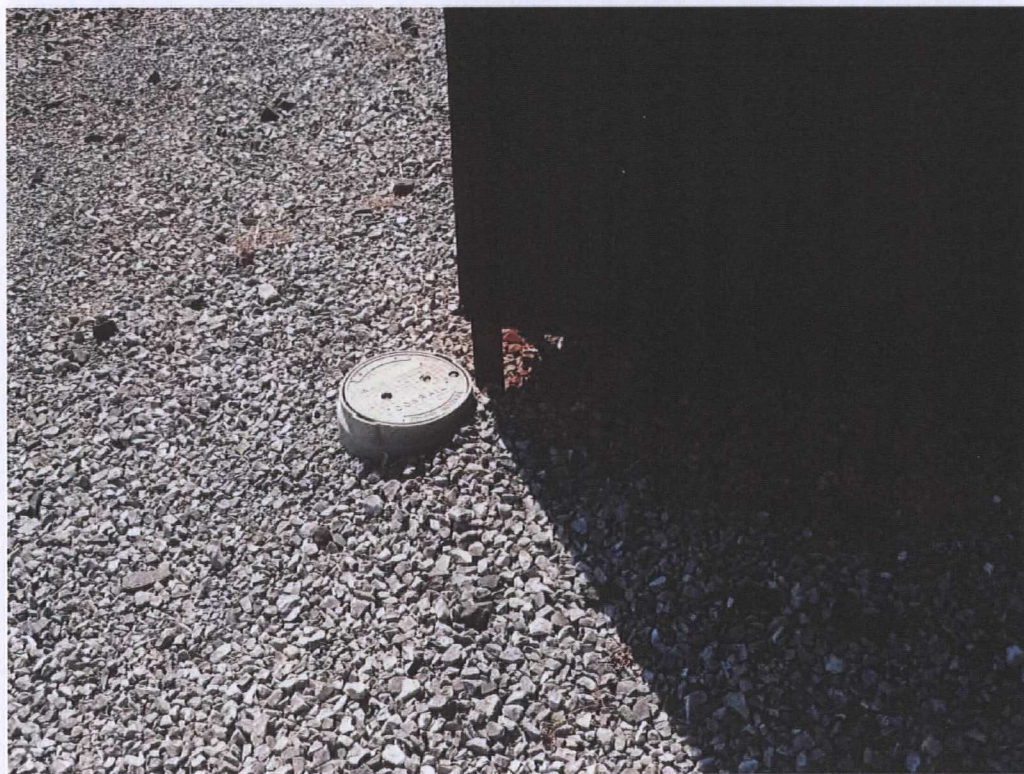
Utility access at corner of shed

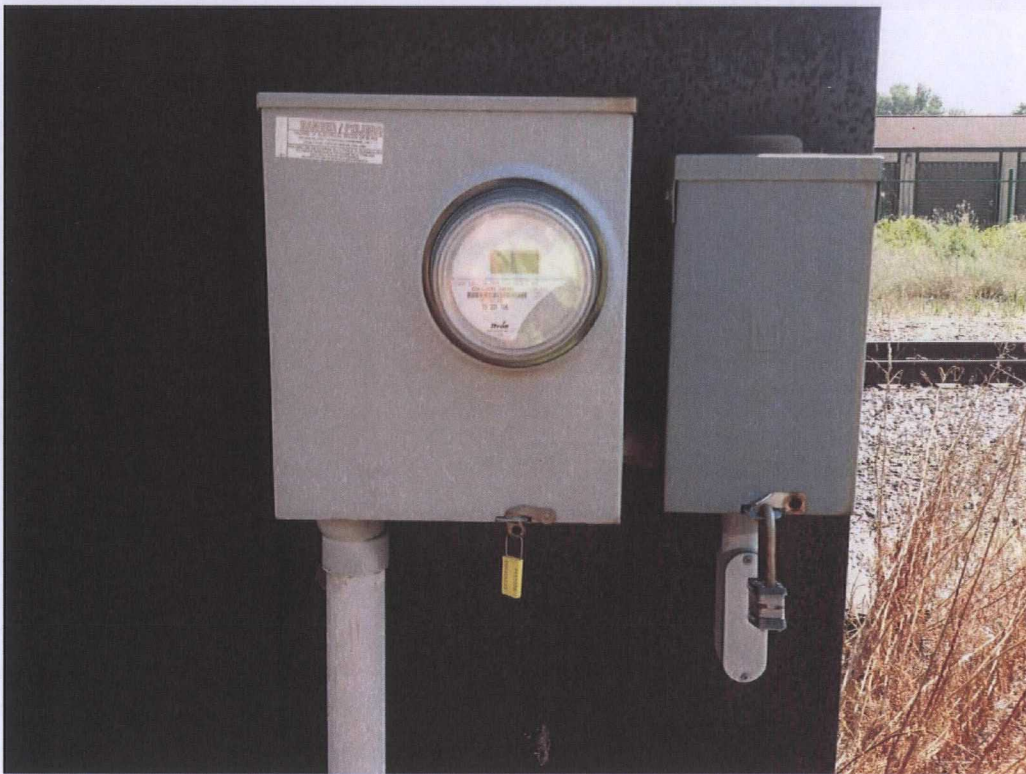
Electric panel on side of shed

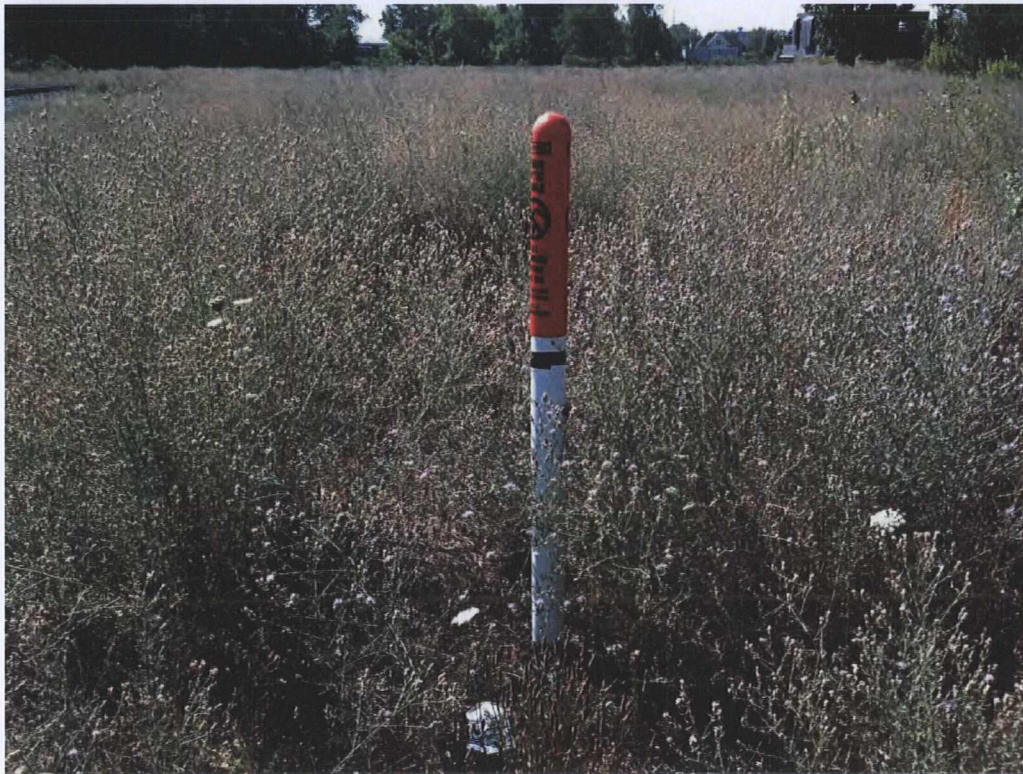
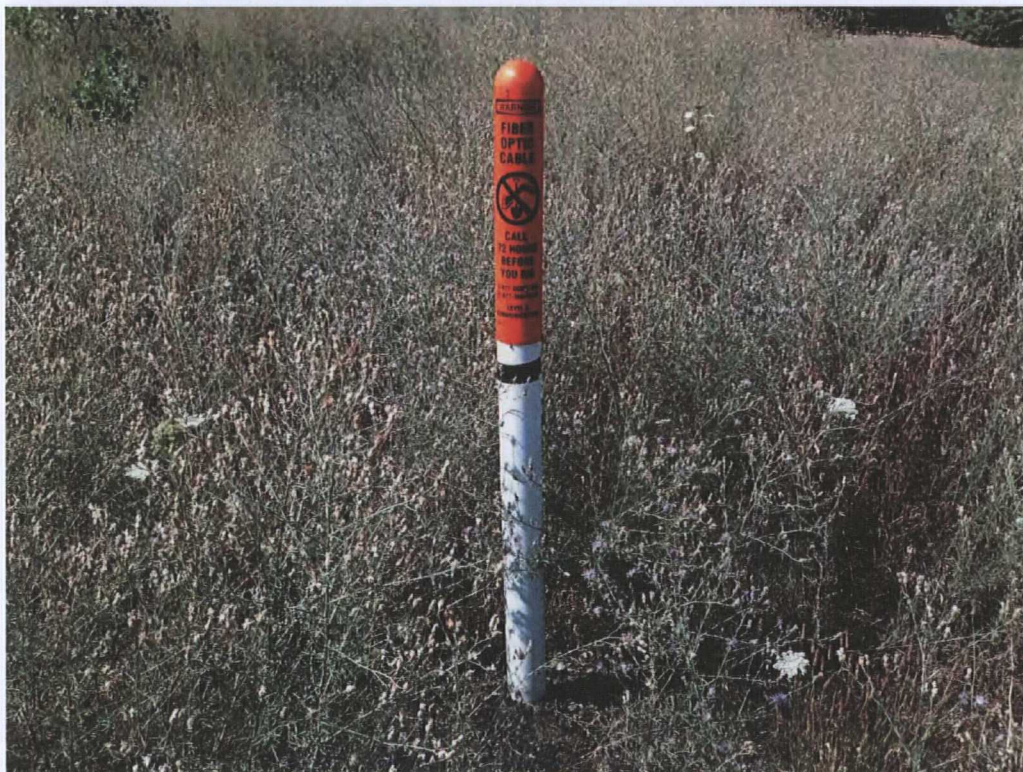
- The marker post appears to be in good condition.

View of marker post looking south

View of marker post looking west

- The marker post should be identified/protected with construction fencing or similar during the work.
